SUBJECT: JUNE 2010 SITE INSPECTION: WEST MIRAMAR LANDFILL, SAN DIEGO COUNTY

Landfill Inspection Report

Name of Facility: West Miramar Landfill
Owner: MCAS Miramar
Operator: City of San Diego
Facility Address: 5180 Convoy Street, S.D.
RB Inspector: Amy Grove

Site Name: West Miramar Landfill
Date: June 22, 2010

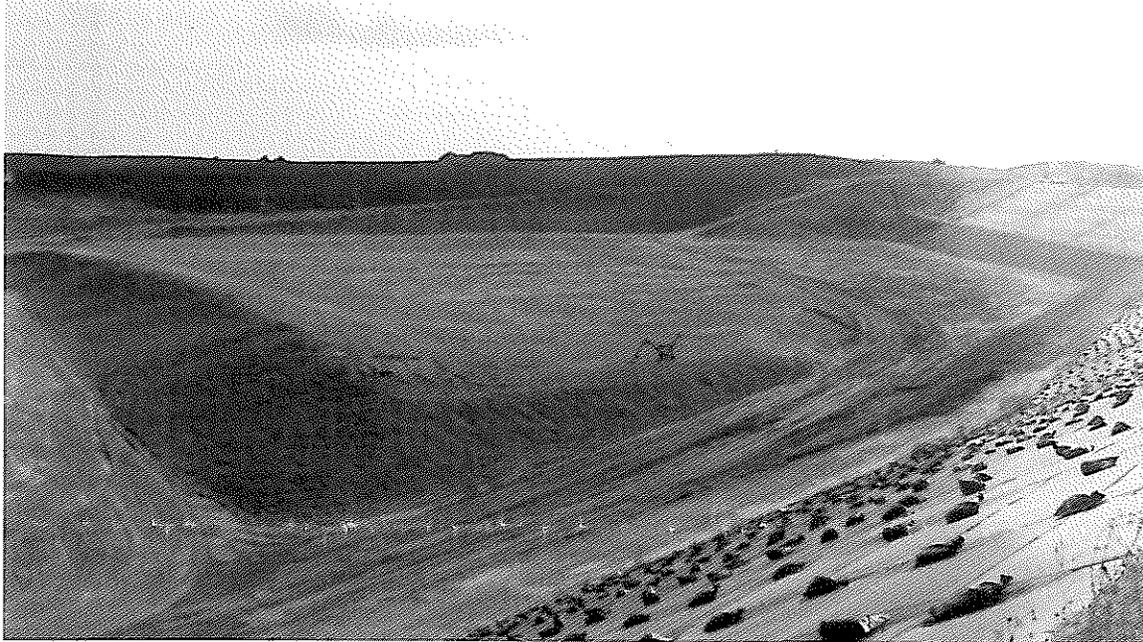
Photo 1: Photo is overlooking the newest lined cell at the landfill. Approximately 20 feet of waste has already been placed in the bottom of the cell. The sideslopes have a sacrificial layer to protect the liner components from the weather.

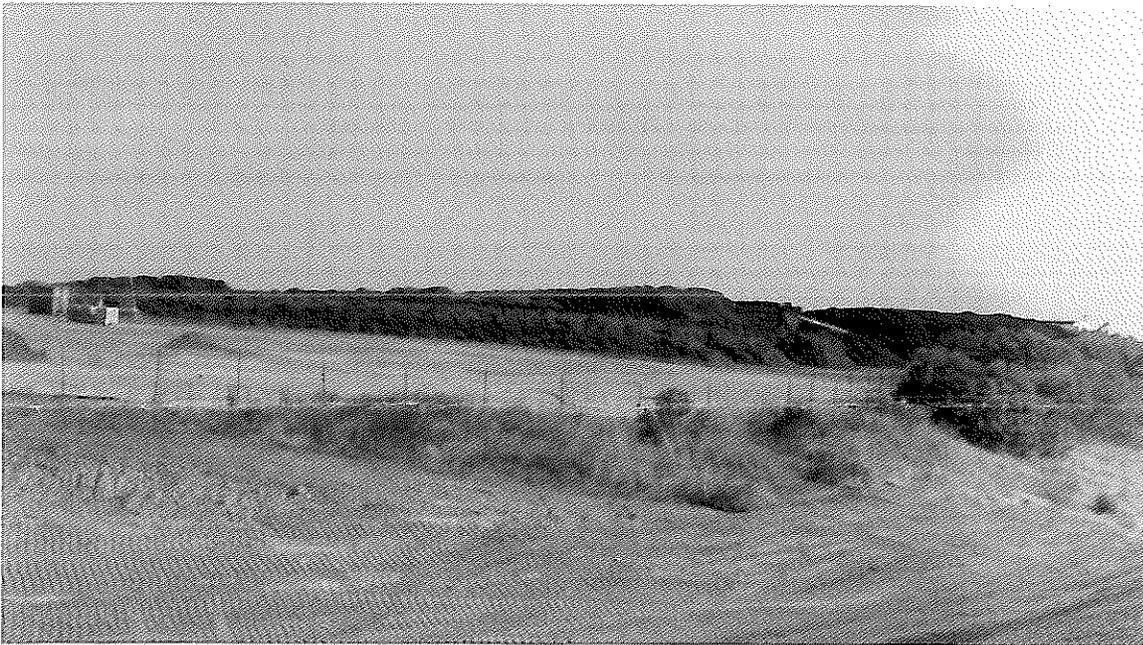
Photo 2: This area is used for composting green waste. The site uses wind rows for drying and maintaining the area.

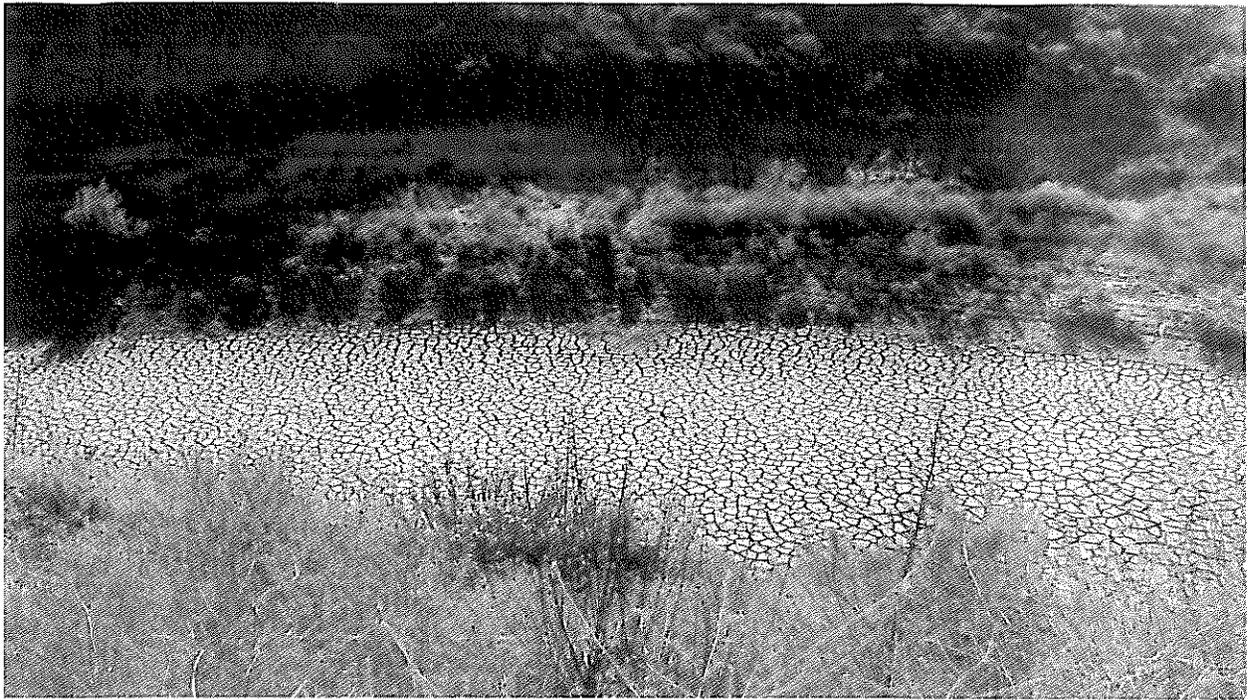
Photo 3: Photo of the main desiltation basin. The City will perform a clean out of the earthen basin prior to the start of the rainy season, if needed.

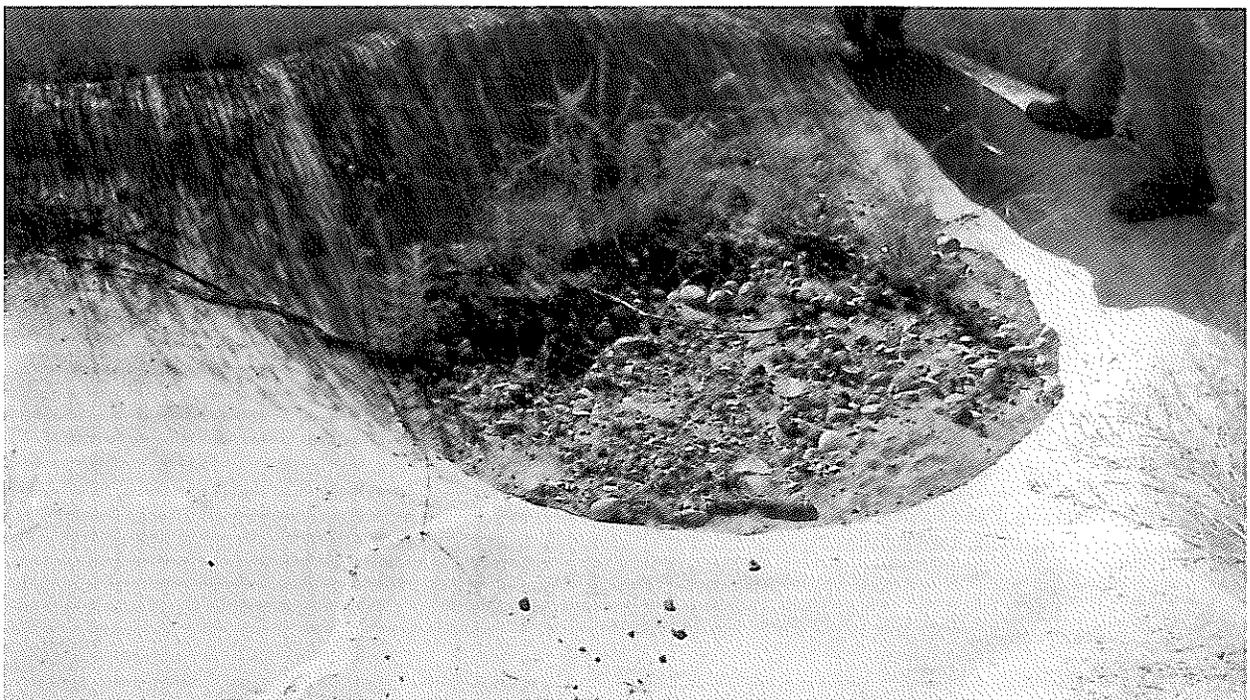
Photo 4: Photo of a perimeter drain culvert. The culvert drains to the main desiltation basin. The City will perform a clean-out of the drain prior to the start of the rainy season.

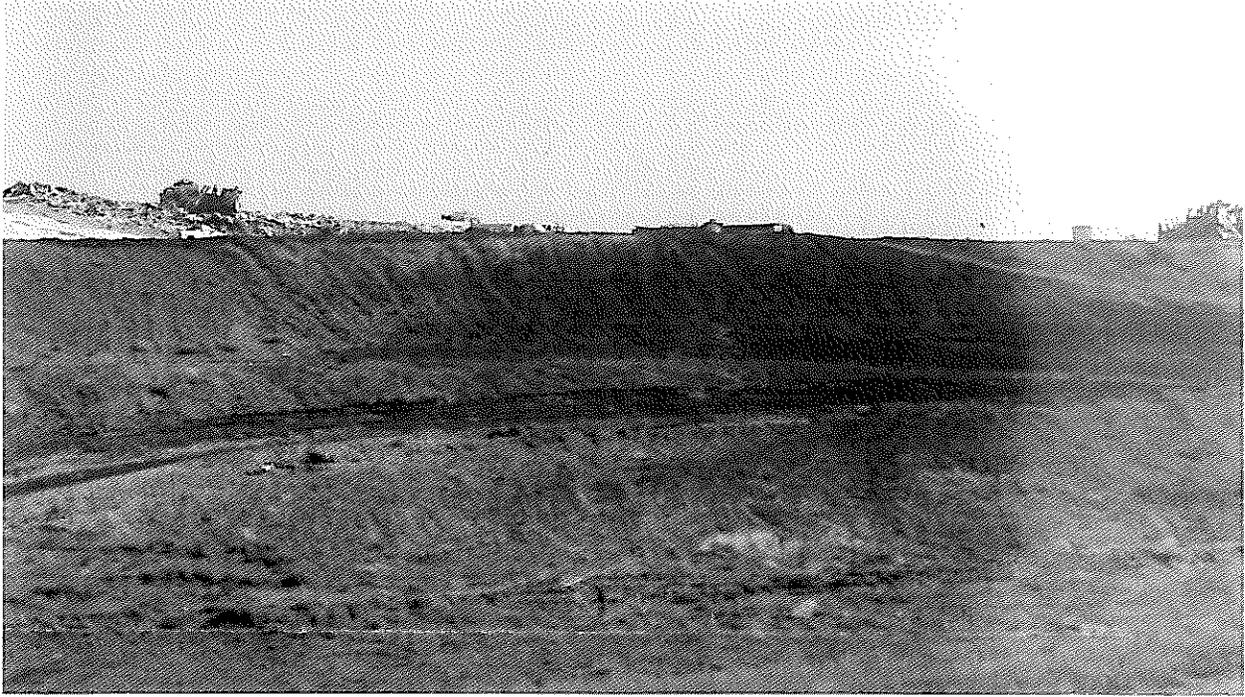
Photo 5: Photo of upper deck where currently landfilling operations are taking place. According to the City of San Diego, operations will continue in this area until final elevations are reached.
